## 2006 FINAL PROJECT REPORT

### Microbial Source Tracking And Virginia's Beach Monitoring Program

#### MEMORANDUM OF AGREEMENT (No. 601-617-93275-2006-VA Tech)

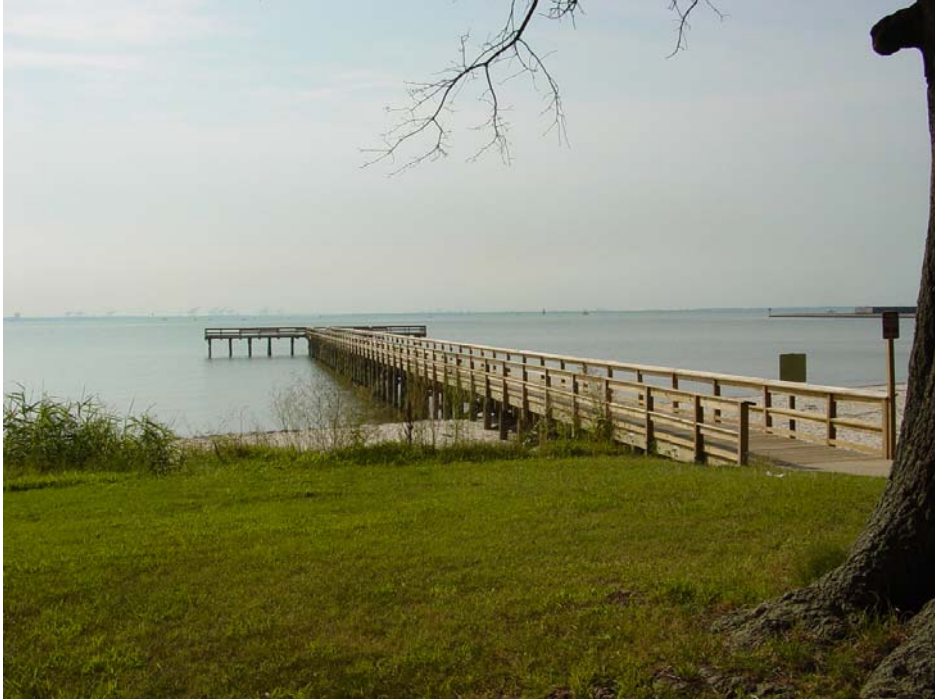
Image 1. The new fishing pier built at King-Lincoln Park in early 2005. Structures like piers attract birds, especially when trash is dumped on the end of the pier. Trash receptacles were added in 2006.

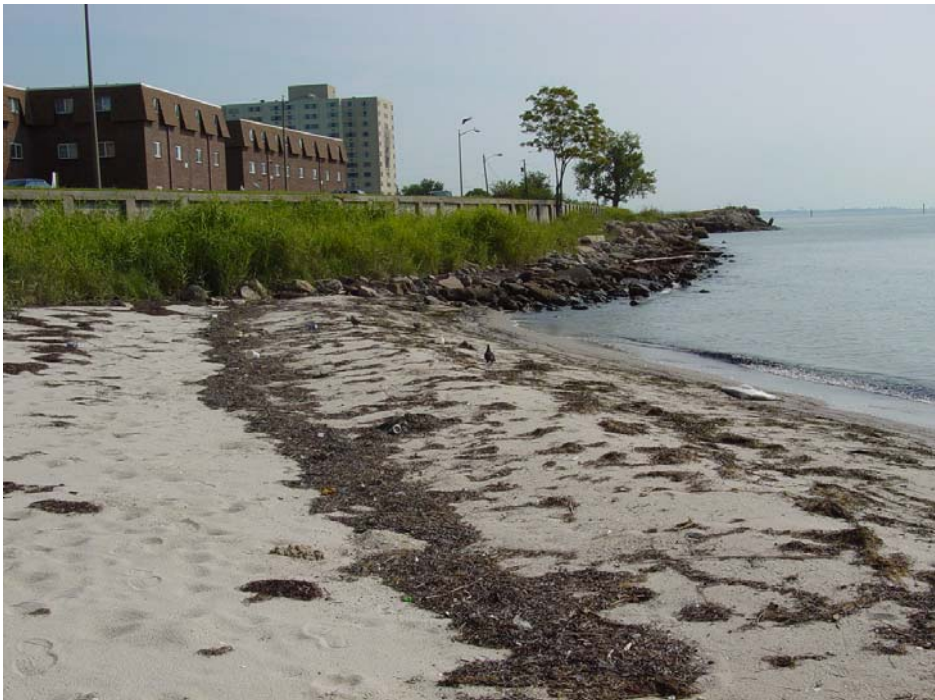
Image 2. Northern part of the beach area between the pier and the apartments. The beach was often littered with trash, including soiled diapers and dog wastes. The storm drain is out of sight to the left.

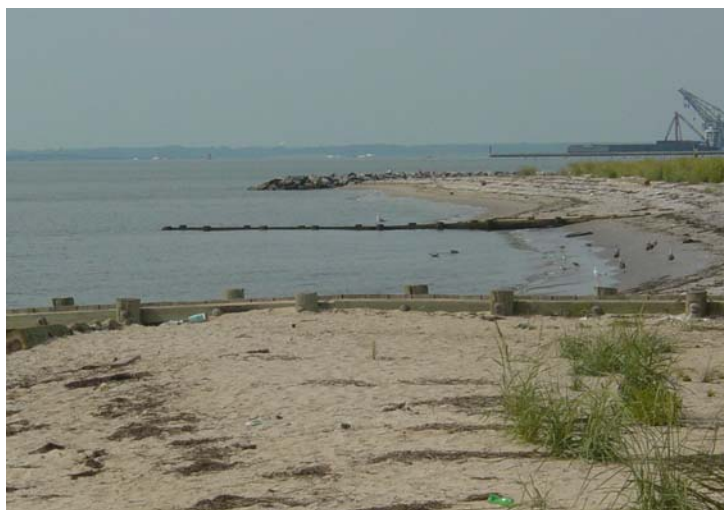
Image 1. Anderson A sampling site location, in between the first and second jetties in the picture.

Trash receptacles are needed here. The view is looking south, and the storm drain is out of site to the north of where the picture was taken.

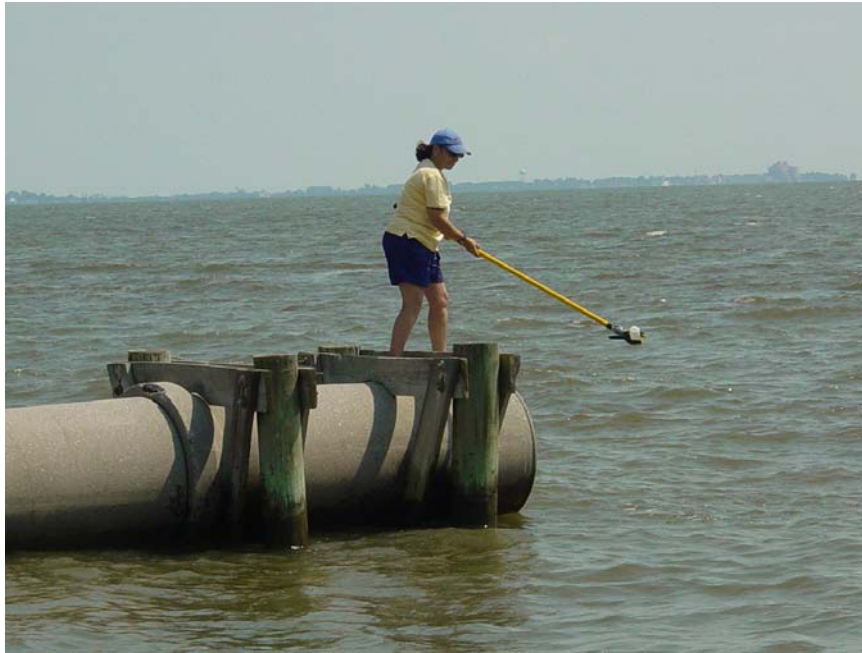
Image 2. Michele Monti collecting a sample from the storm drain, August 2005.

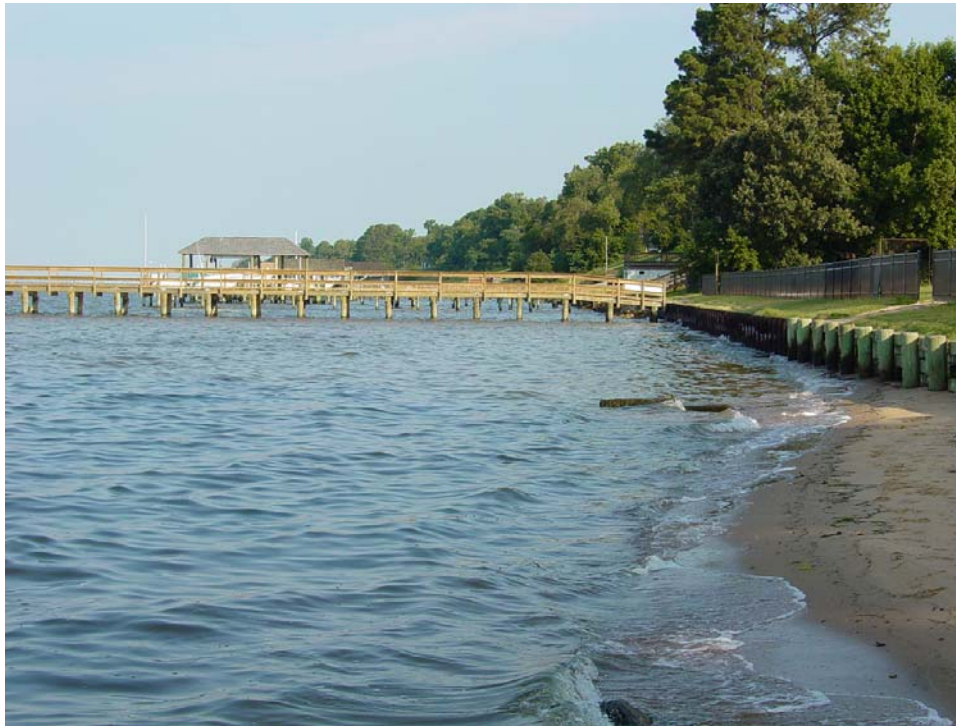
Image 1. Hilton Beach at high tide on the James River, when very little of the beach is above water. The storm drain is out of sight to the right, the fishing pier is on the western end of the beach.

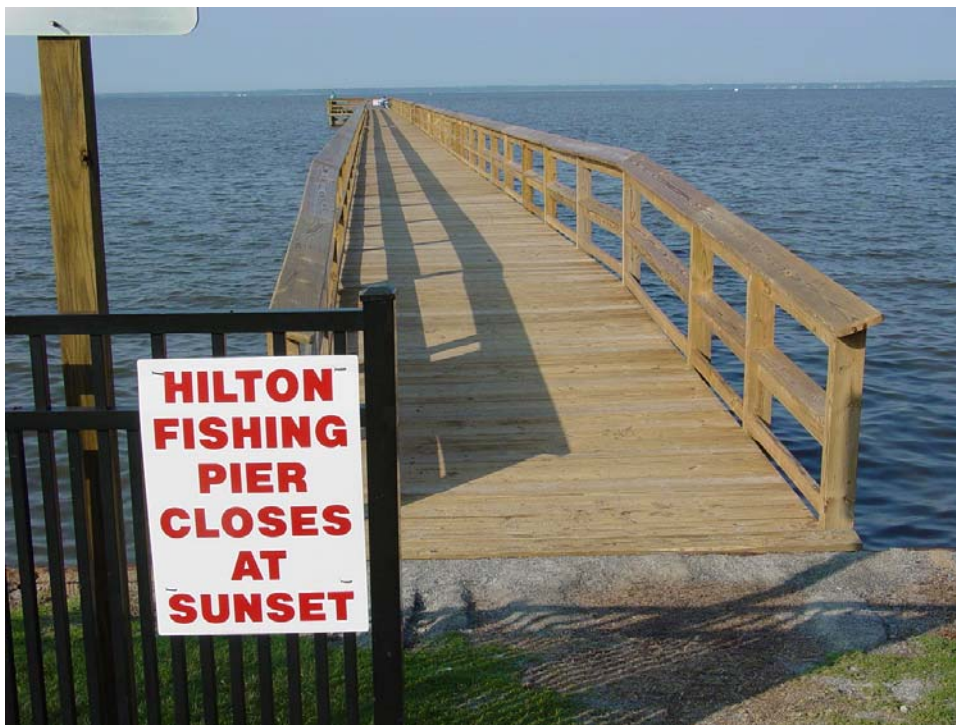
Image 2. The fishing pier at Hilton Beach.

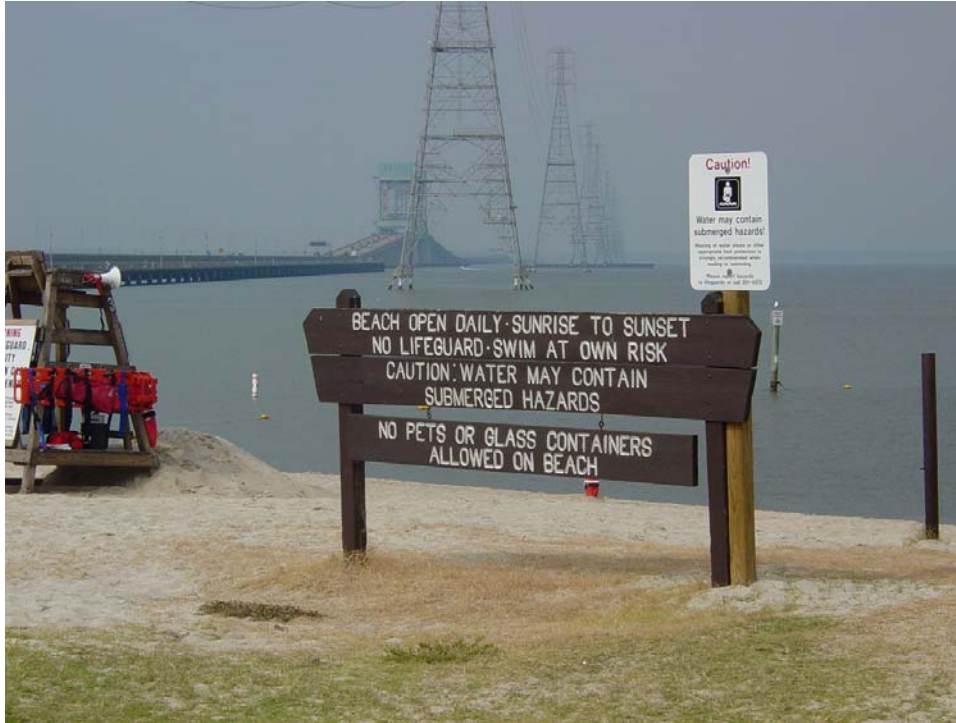
Figure 1. Huntington Beach, the swimming area (within the buoys) can be seen past the lifeguard station. Site 205 is to the left and site 206 is to the right of the large sign.

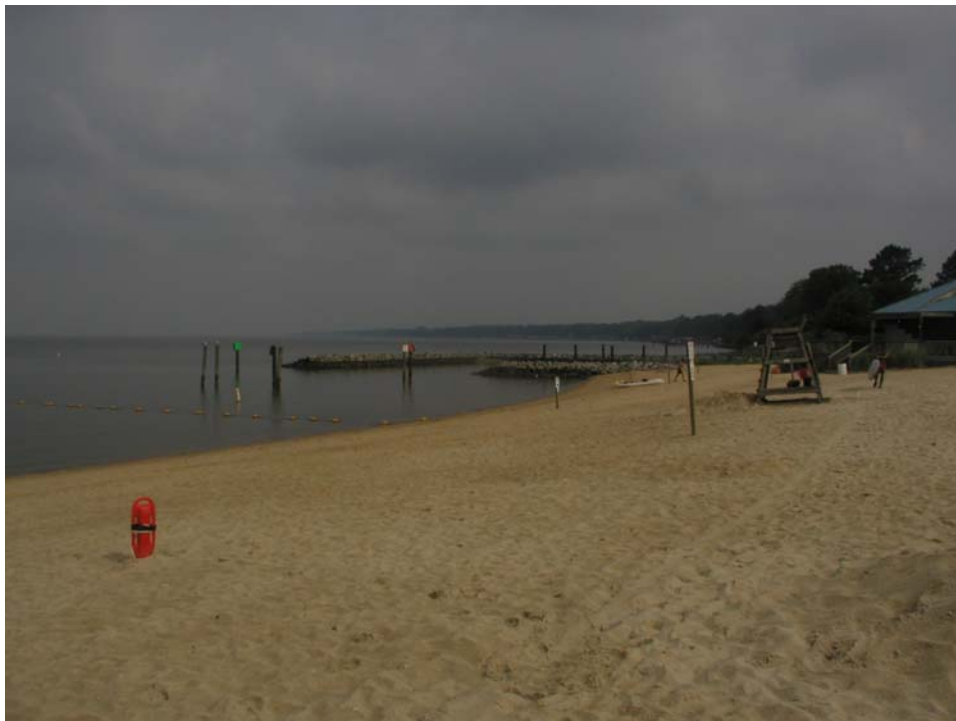
Figure 2. Site 207 is within the swimming area to the left, near the buoys, and the public boat ramp can be seen past the swimming area (upriver).

Sampling by the VT staff will concentrate on the waters around the boat ramp and the western end of the swimming area, where the high counts but no evidence of optical brighteners were found. The boat ramp is upstream from the swimming area and this may have helped pollution from the boat ramp area move into the swimming zone. Samplings in 2007 will be coordinated again with the VDH staff so that additional collections can be made (by either VDH or VT staff) whenever advisories are posted in an attempt to relate advisories to certain conditions or events such as tides, storms, wind direction, and bird patterns. This may help explain the origins of the high *Enterococcus* counts that might result in sporadic advisories at this beach. Careful attention to the activities of boaters to prevent waste dumping in the water should help Huntington Beach hopefully remain clear of advisories in 2007, as it did in 2005.

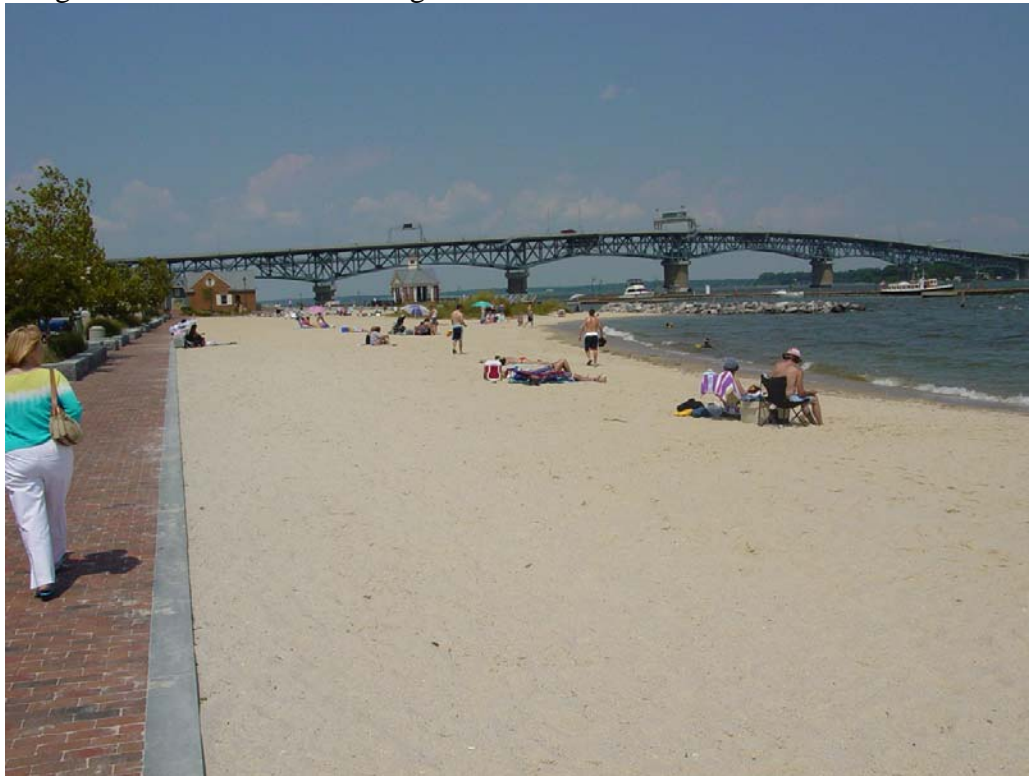
Image 2. The eastern swimming area at Yorktown Beach.

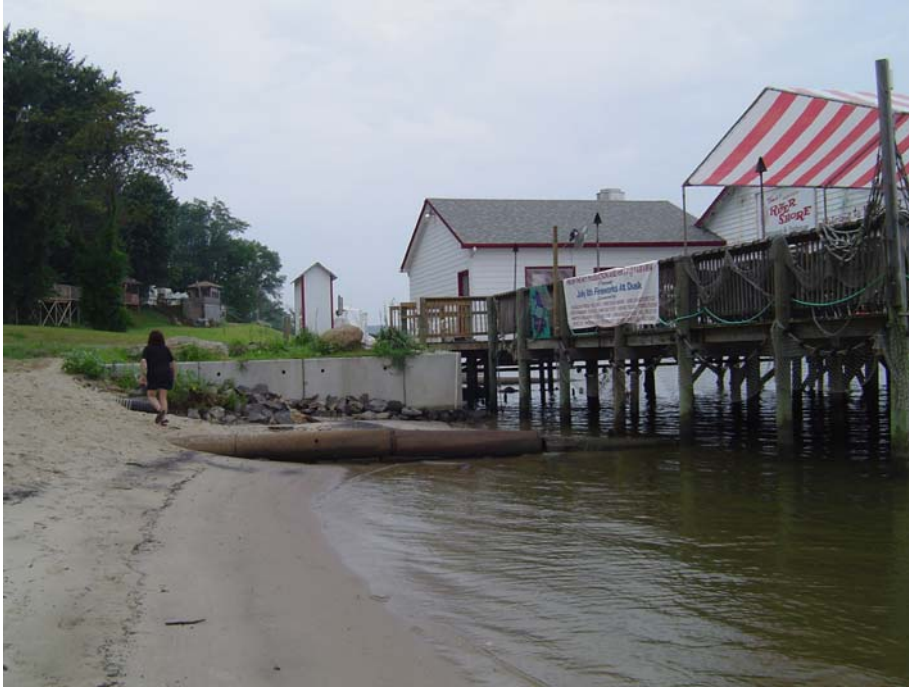
Image 1. Restaurant and drainage pipe adjacent to the swimming area at Fairview Beach (see image 5). The swimming area is behind the photographer.

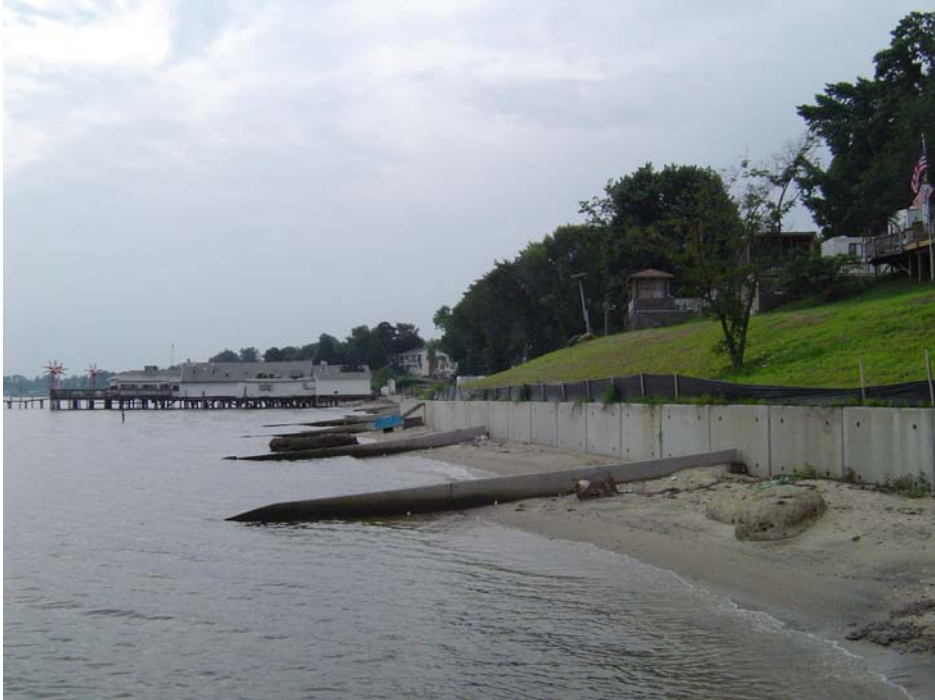
Image 4. Upriver shore-line improvements, with the restaurant in the background. Tropical storm Ernesto washed several of the concrete wall blocks into the water on September 1 and 2, 2006.

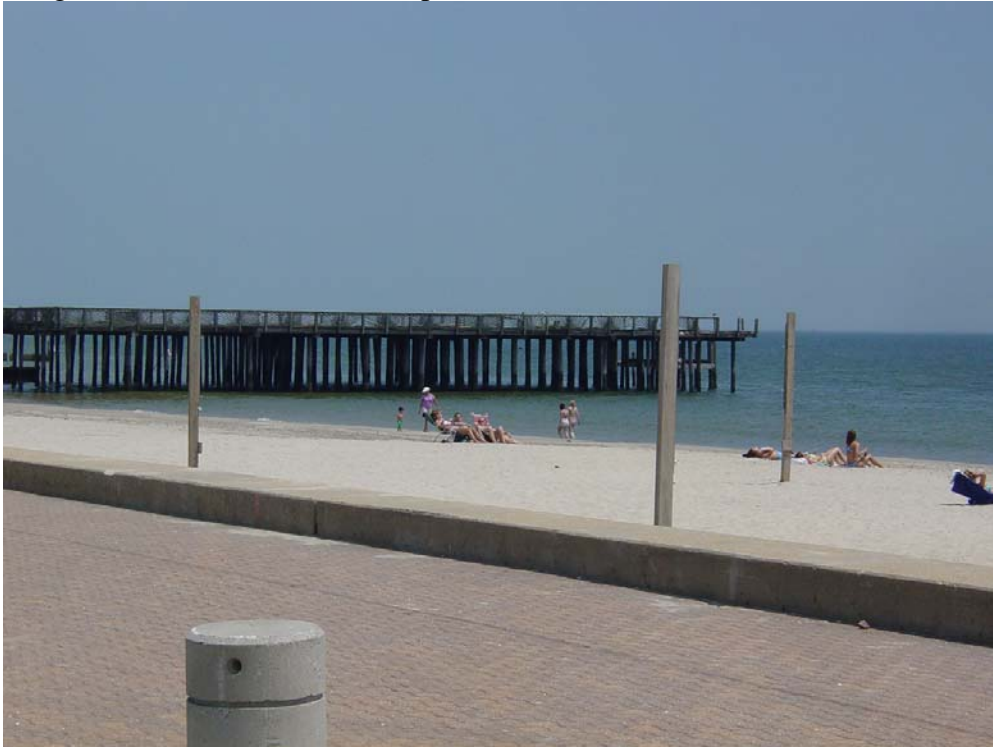
Image 2. Beach and condemned pier in 2004.

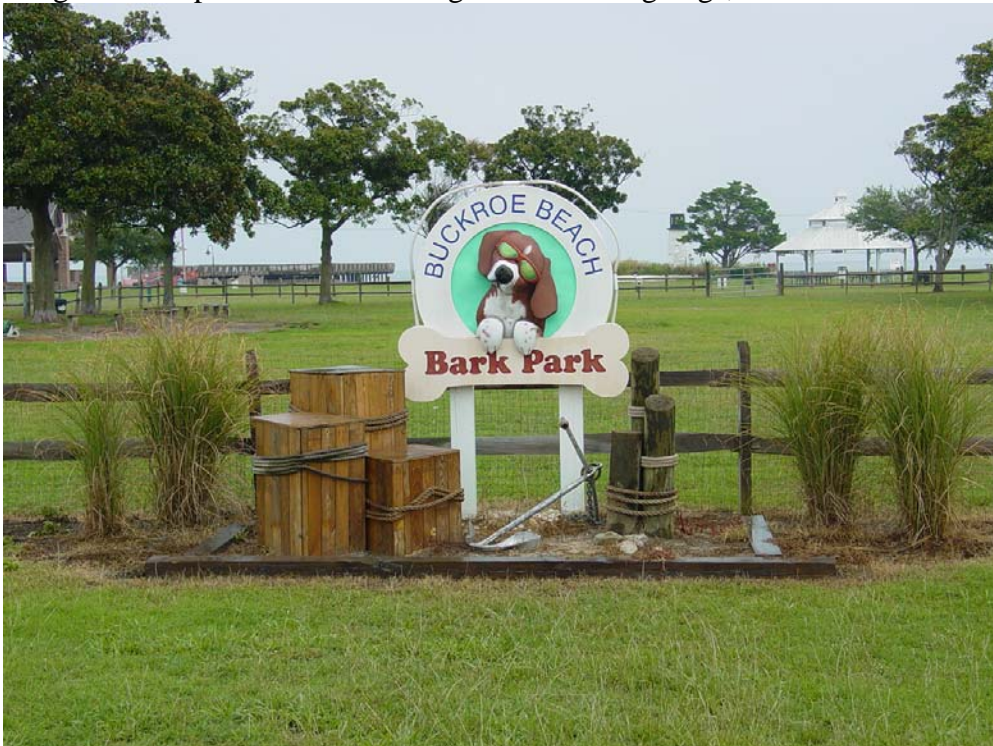
Image 3. Area provided for walking and exercising dogs, 2005 and 2006.

The images below illustrate current conditions at Buckroe Beach. Image 1 shows the condemned pier in 2005 and image 2 shows the pier in 2004. By comparing the two images, the size of the beach extension can readily be seen as much of the pier in image 1 is now over sand instead of water. Plans are underway to rebuild the pier, but construction was halted in 2005 and 2006 by the discovery of nesting shorebirds that were identified as endangered (image 4). Officials plan on having the pier rebuilt and open for the 2007 swimming season, and construction of the new pier is now underway. A “Bark Park” (image 3) was added in 2005 as a place to walk and exercise dogs and to encourage pet owners to not take their pets on the beach. Receptacles for pet wastes are provided at the park. This has helped lower the source tracking results attributed to dogs from 2004 through 2006 (9.6% in 2006, Table 4).

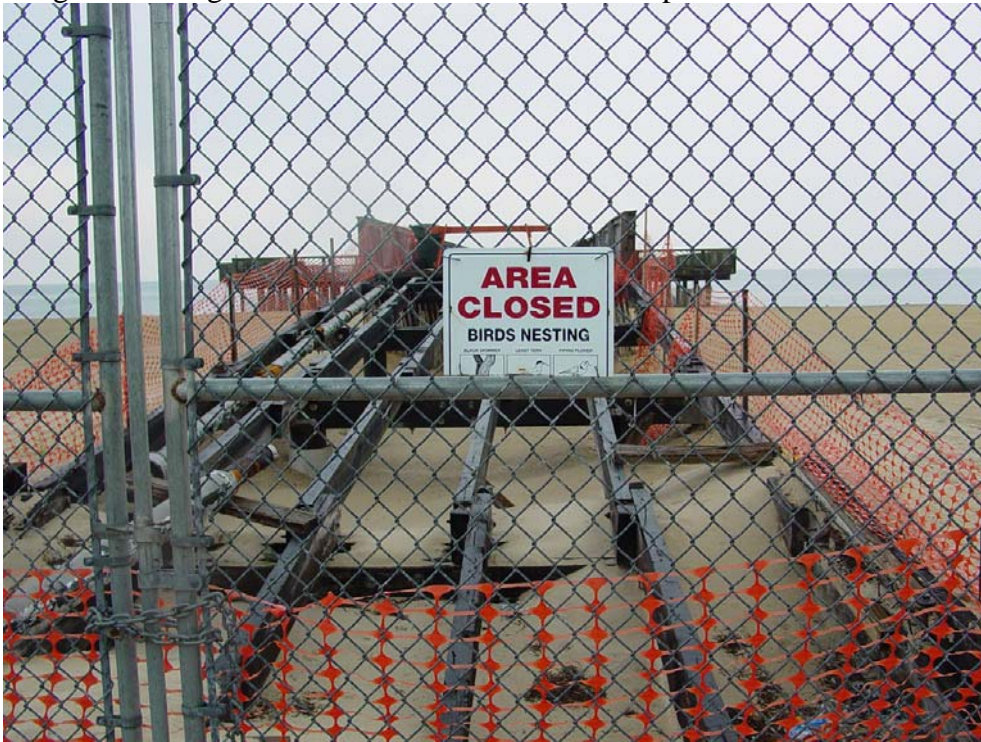
Image 4. Nesting birds halted reconstruction of the pier in summers of 2005 and 2006.

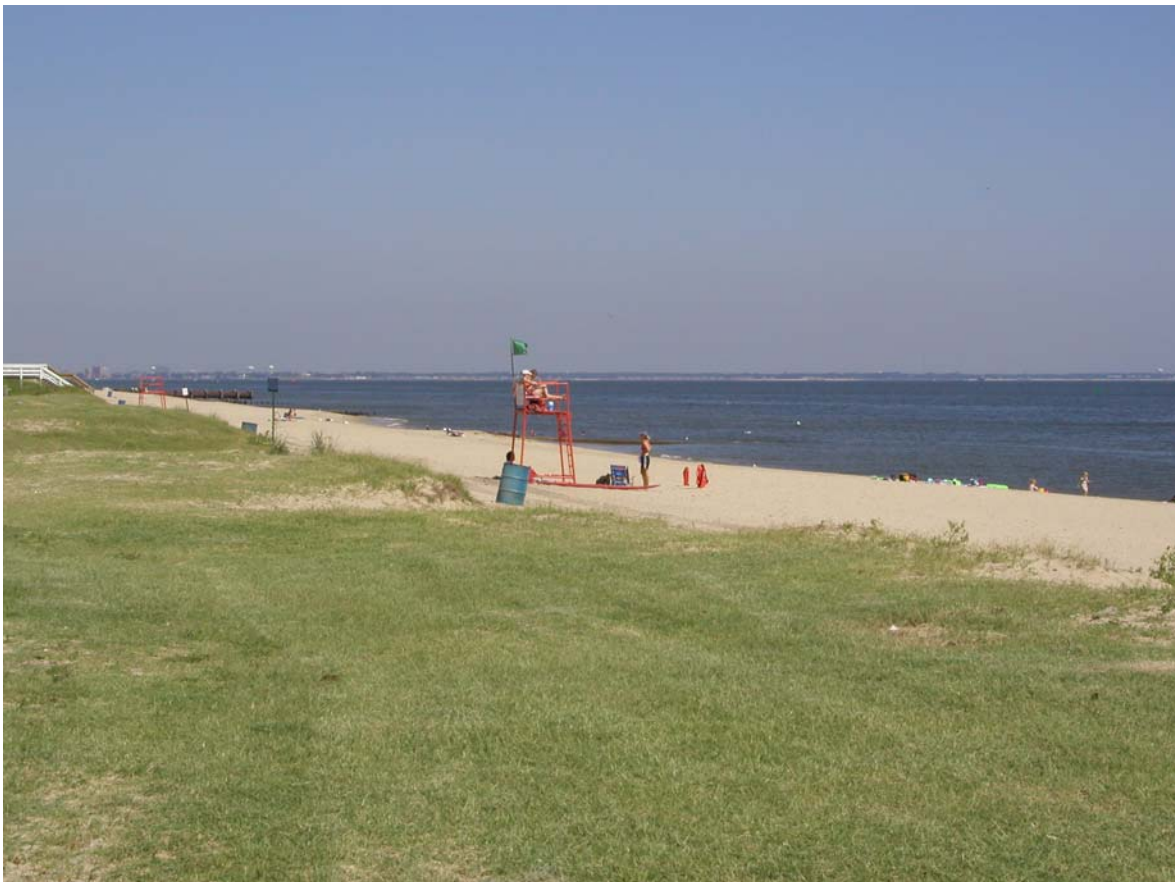
Image 1. Ocean View Park in 2006, a well-maintained and clean beach.

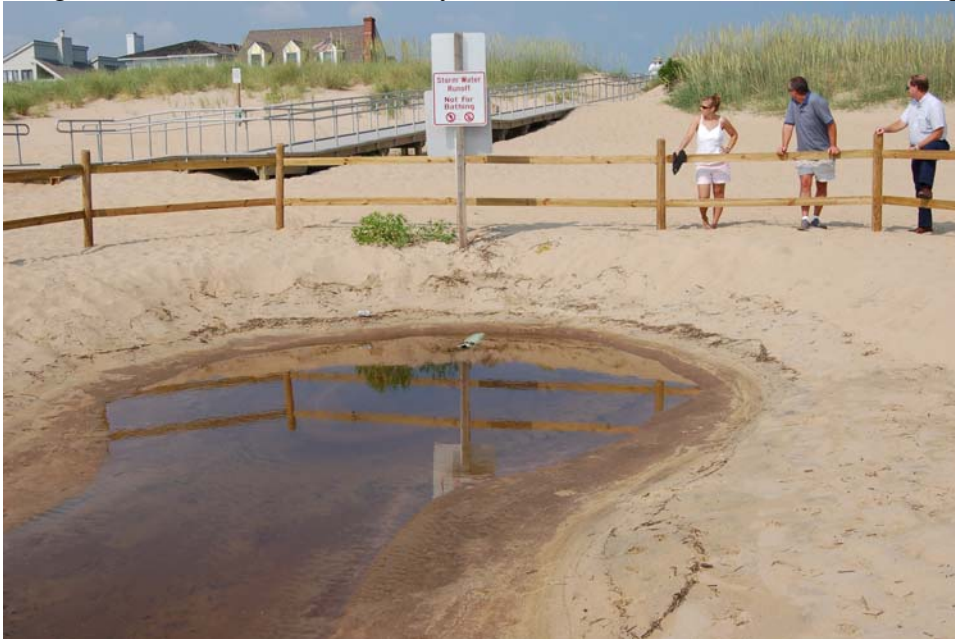
Image 1. 64<sup>th</sup> Street Outfall on July 20, 2006, when the 63<sup>rd</sup> Street station pump was off.

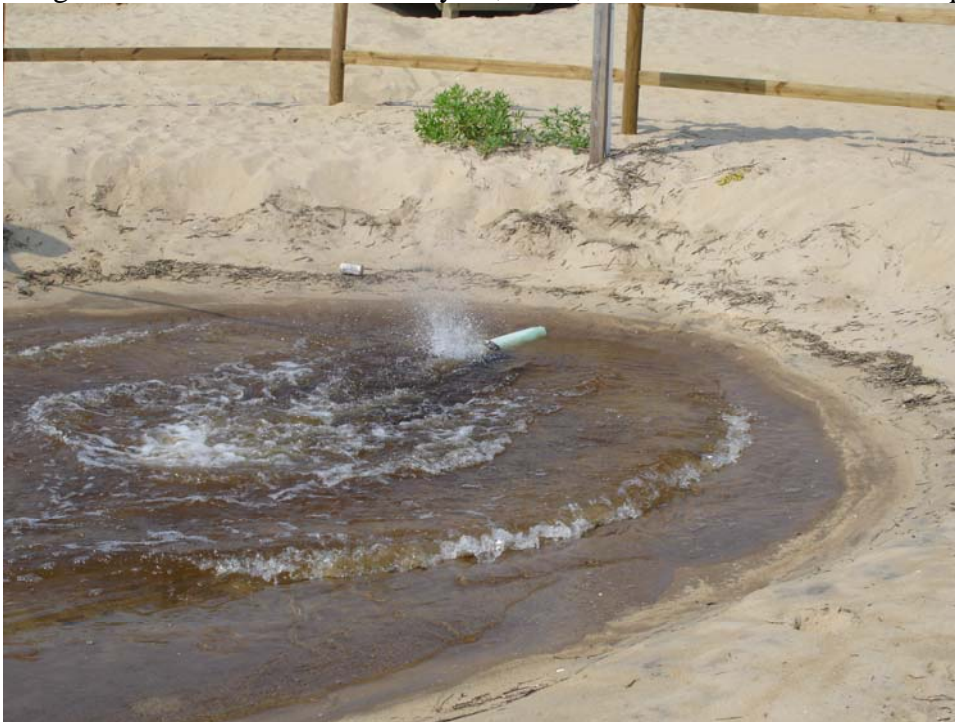
Image 2. 64<sup>th</sup> Street Outfall on July 20, 2006, when the 63<sup>rd</sup> Street station pump was on.

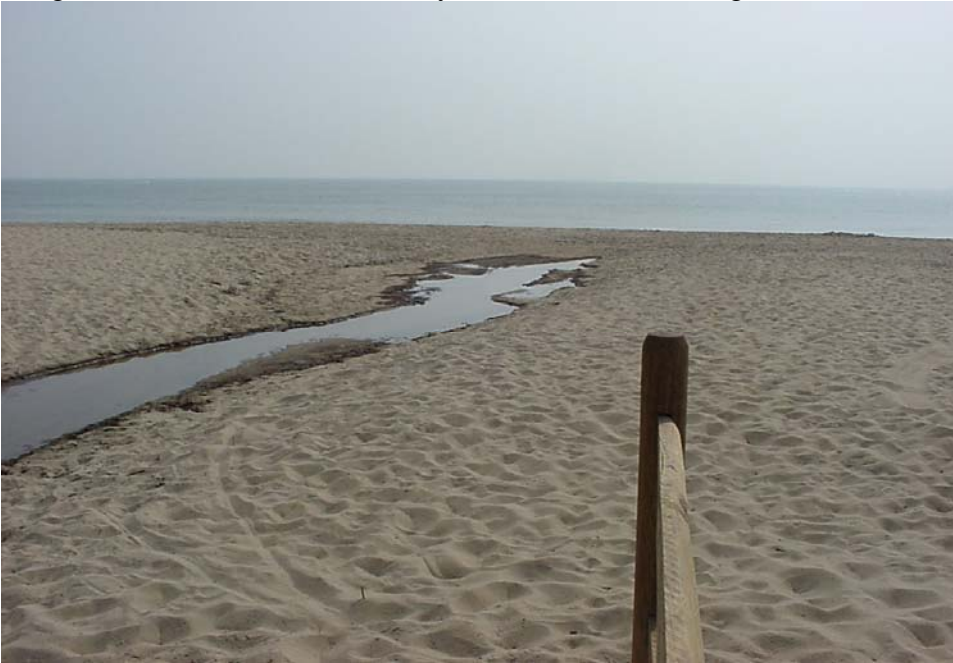
Image 3. 64<sup>th</sup> Street Outfall on July 20, 2006; the discharge drains down the beach.

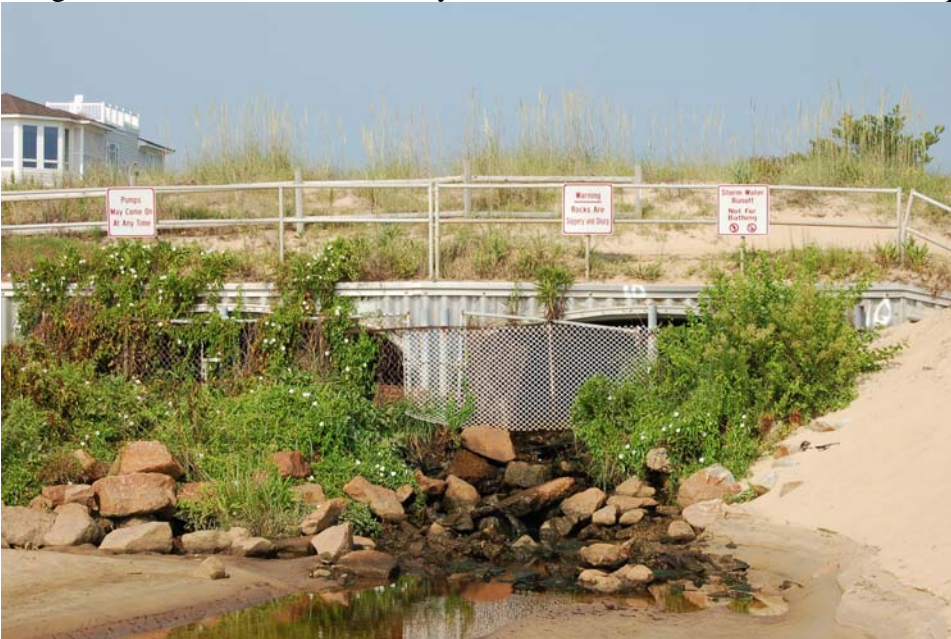
Image 4. 79<sup>th</sup> Street Outfall on July 20, 2006, when the 78<sup>th</sup> Street station pump was off.

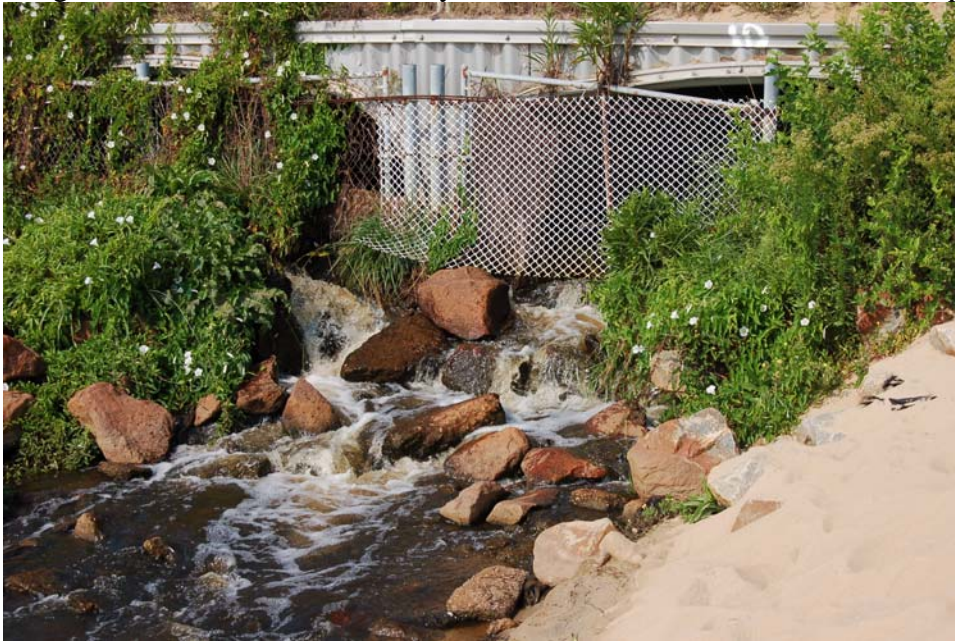
Image 5. 79<sup>th</sup> Street Outfall on July 20, 2006, when the 78<sup>th</sup> Street station pump was on.

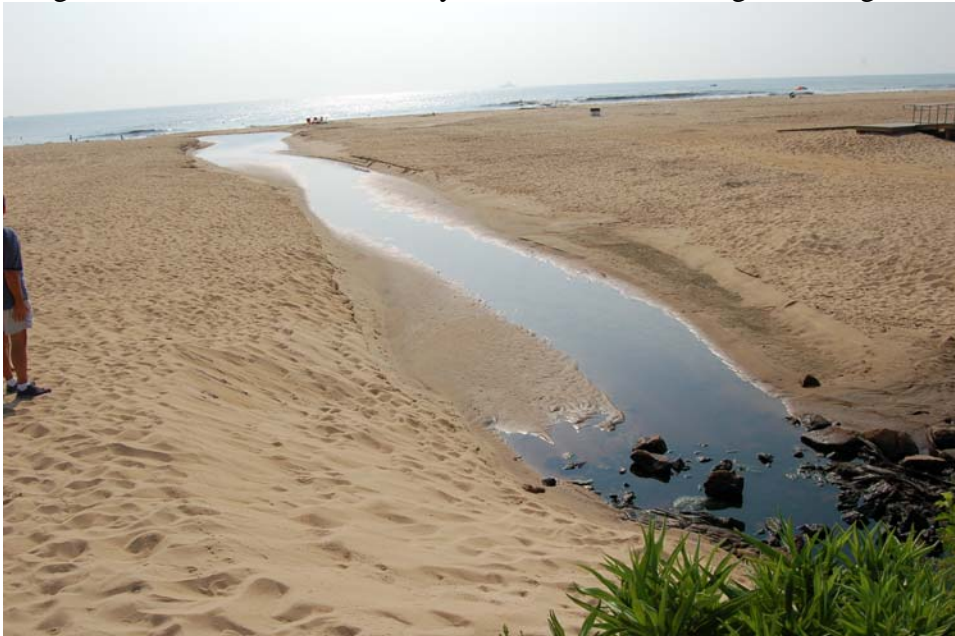
Image 6. 79<sup>th</sup> Street Outfall on July 20, 2006; the discharge draining down the beach.

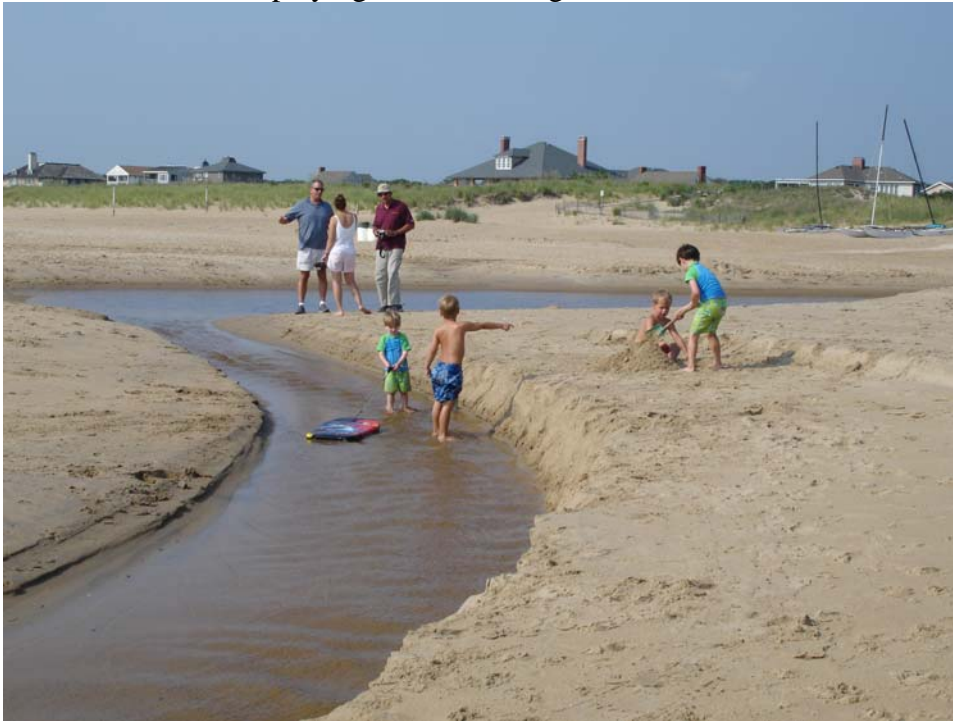
Image 7. 79<sup>th</sup> Street Outfall on July 20, 2006; the discharge down the beach near the ocean, with children playing in the discharge.

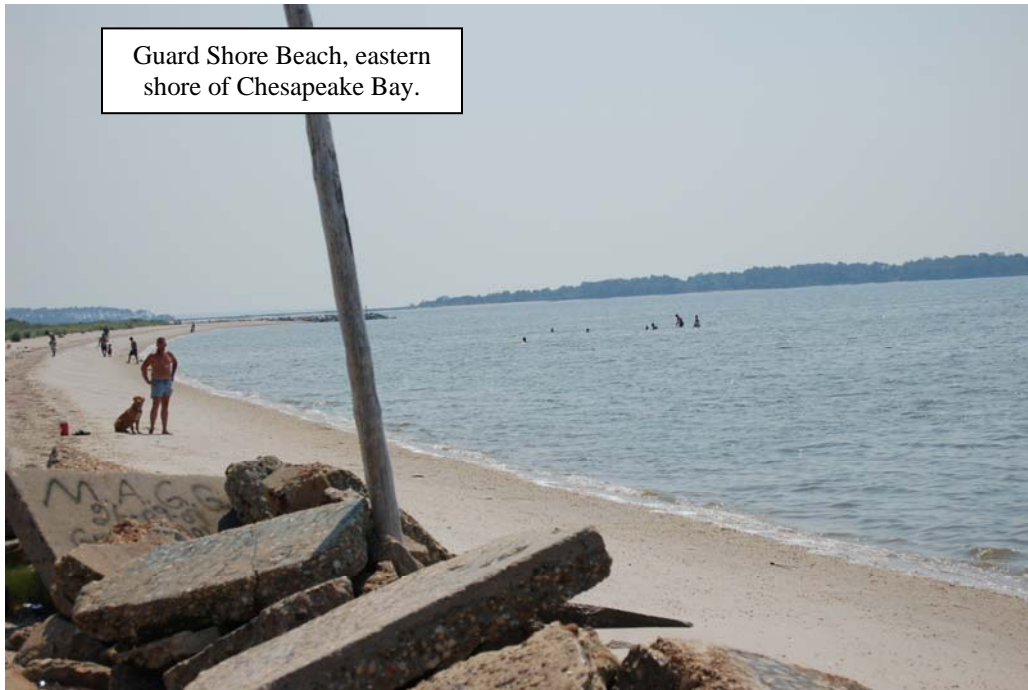
Guard Shore is an undeveloped beach that is a favorite with migrant workers, mainly on weekends (see picture above). With no services at this beach, both human and dog wastes were observed when samples were collected, and birds were attracted to the trash left on the beach. Periodic postings should be expected on Guard Shore, especially if samples are collected near the weekend, when most of the activities on the beach occur. Larger crowds used the beach in 2005 and 2006, as compared to 2004, and more frequent advisories may occur in the future if this trend continues (although there were no advisories in 2006). For the following results, the monitoring was done by the DSS-VDH lab in Accomac and the membrane-filtration plates were shipped to VT (every date where counts above 10 CFU/100 mL were obtained, Table 1).

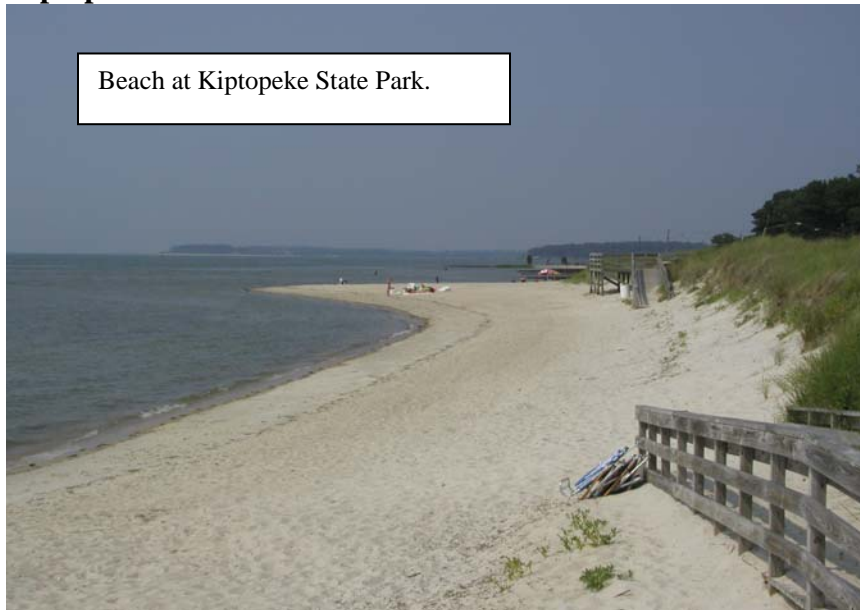
### Kiptopeke State Park

Kiptopeke State Park provides sanitary facilities and dogs are not allowed on the beach. State

Park staff monitor the beach and help maintain a clean beach environment (see picture above). Postings should not be a problem at this beach, and there were no advisories in 2004-2006. Only 2 of 17 VDH samples in 2006 were above 10 CFU/100 mL, and both of these were below 50 CFU/100 mL.

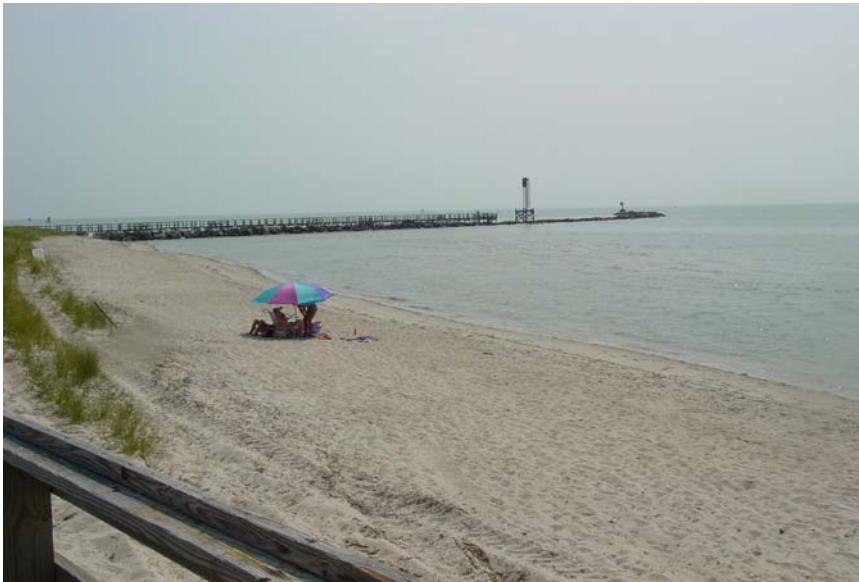
**Cape Charles Harbor Beach** (The beach at Cape Charles Harbor, looking south).

Cape Charles provides sanitary facilities, but does not ban dogs from the beach. However, no dog wastes were observed on the beach during visits by the VT staff in 2005 and 2006. Numerous storm drains enter the water just north of the beach area (see picture above), and water does flow periodically from these drains, especially during storm events. These storm drains could cause problems for Cape Charles Beach in a wet summer, and should be monitored to assess that possibility (see picture below). For the VDH monitoring counts for Cape Charles in 2006, 7 of 17 samples (41.2%) exceeded 10 CFU/100 mL, but only 3 were above 50 CFU/100 mL (and below 100 CFU/100 mL).

Minimal monitoring by the VT staff will be necessary on the Eastern Shore in 2007. However, continued observation of Cape Charles Harbor storm drain outfalls will be done in 2007, especially around storm events, by VDH staff, and Guard Shore will be examined closer to weekends when the beach is being used. No monitoring at the Eastern Shore, other than what is planned by VDH staff, will be needed in 2007 unless advisories occur.
